# Leak Detection and ROI

Jim Riffle, CIH, CIT

# Objective

- Discuss two methods for identifying energy leaks and calculating the associated return on investment.
  - Infrared Thermography
  - Ultrasonic

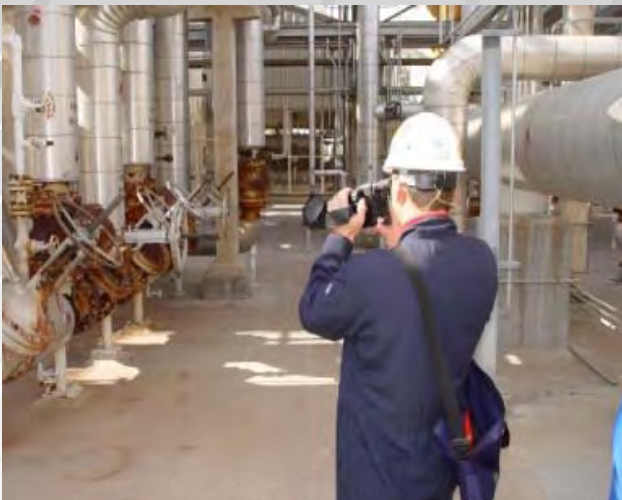
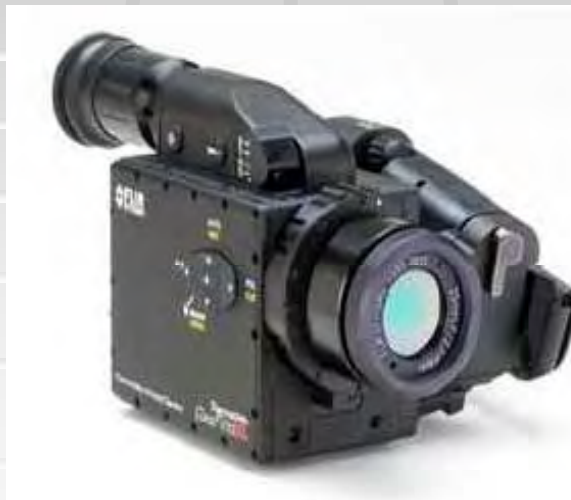
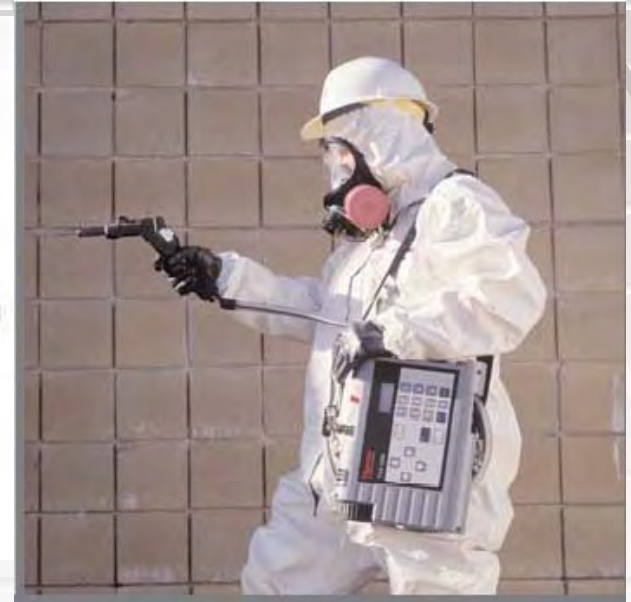
# Gas Survey Cameras

Midwave - Benzene, Natural Gas, others

Long wave – SF6, FREON, others

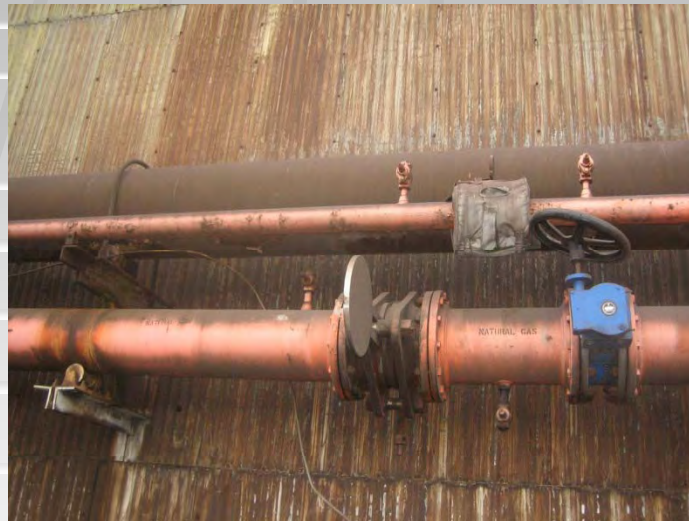
- 56 inch mill east side fitting near pan blank  
0.1 cfm, \$683.80 per year

Location Component	Yearly Leak Rate (Mcf/yr)	Gas Price MCF (\$)	Annual Costs
56 inch mill near swing pan blank	52.6	13	\$683.80
56 inch mill east side gas line on roof dresser coupling	1577	13	\$20,501.00
56 inch mill west side gas line on roof dresser coupling	1577	13	\$20,501.00
Burma Road Gas Line Near River – Underground leak, travelling up electric pole 28	5256	13	\$68,328.00
		<b>Total</b>	<b>\$110,013.80</b>

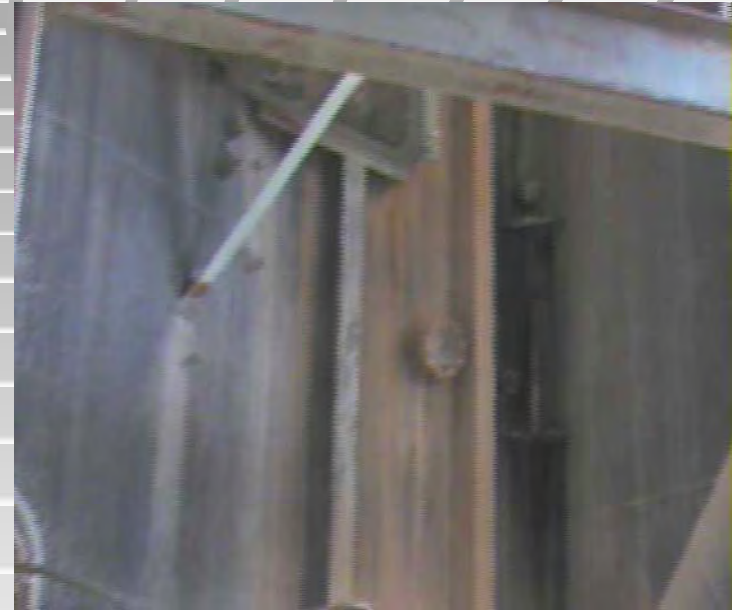
# Refractory Survey

LOCATION	FR4-HV3 cross-over; North wall
PROBLEM	Severe refractory loss in areas
RECOMMENDATION	Put air on/inject area with refractory/monitor status

Emissivity	Max Temp F	MinTemp F	Average Temperature	Temperature Units
0.90	855.4	176.2	374.4	F

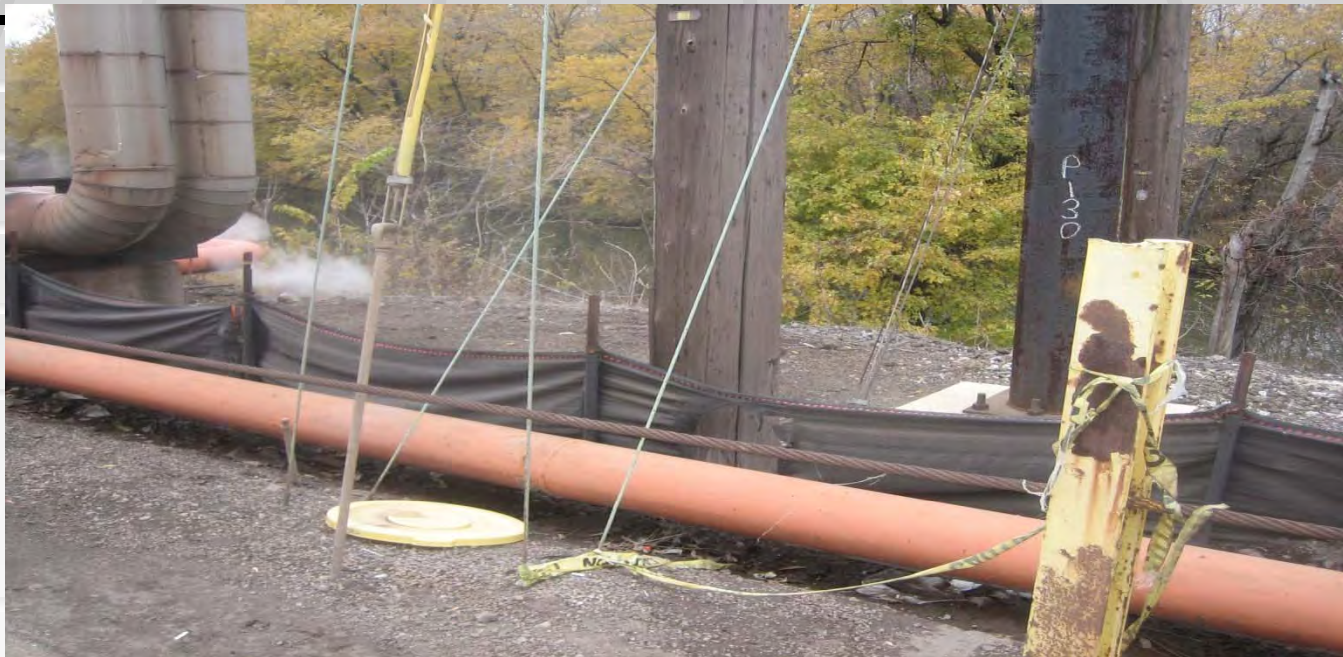
# Ultrasonic Detected

- Gas line near river – underground leak travelling up
- Electric pole #28 - 10 cfm, \$68,328.00 per year.

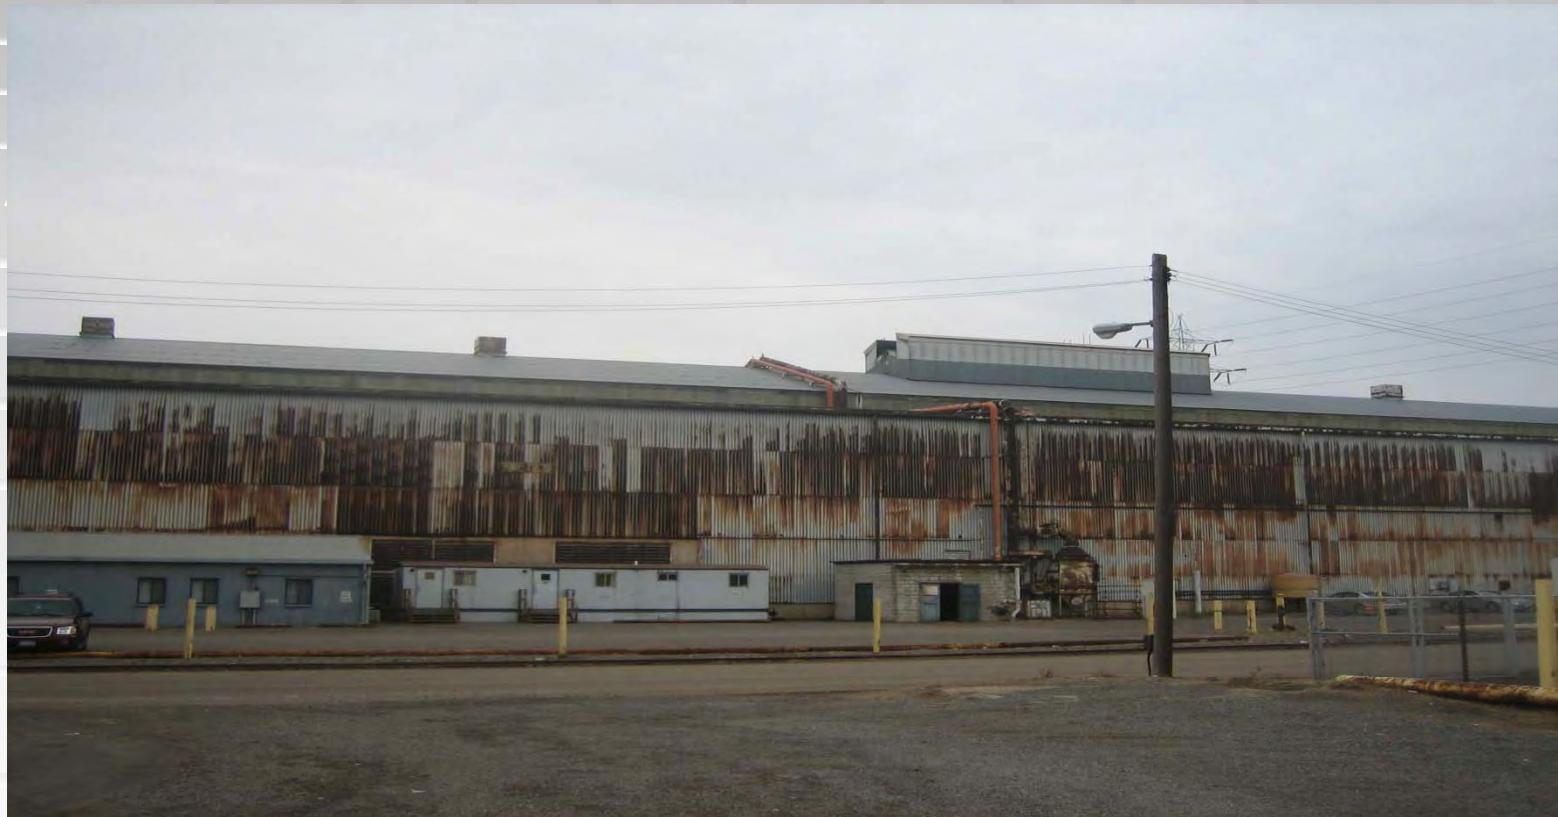
# Ultrasonic Non- Detected

- 56 inch mill west side gas line on roof - 3.0 cfm, \$20,501.00 per year

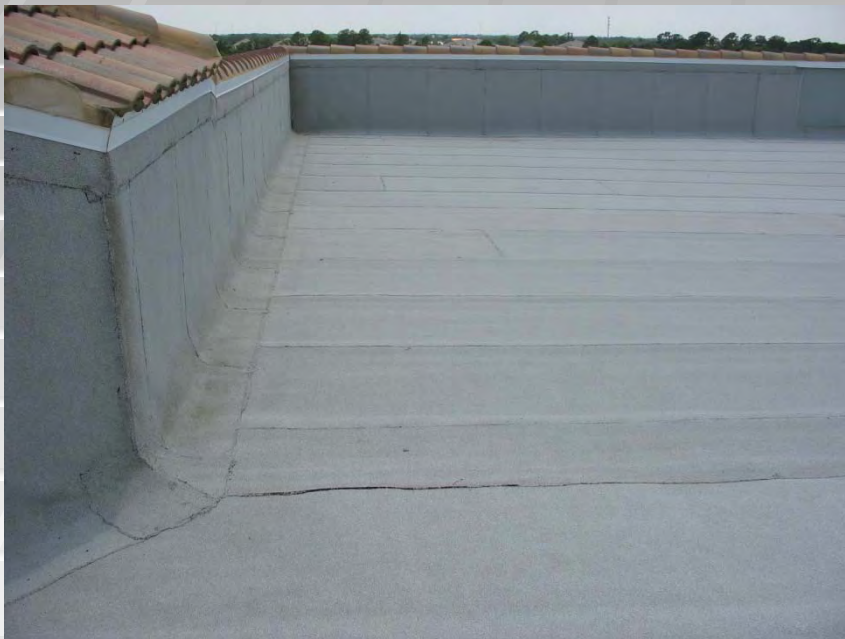
# Thermal Capacitance Florida Condo - Night

- Water has a high thermal capacitance or ability to store heat.
- Wet areas of building material that are evaluated at sunset will maintain the heat absorbed from the daytime sunlight better than the surrounding dry building materials.
